Manhole Inspection Summary

Manhole # S110__011MH

Inspection Is Incomplete Rating: **4) Poor**

Location Address: **319 S Caton Ave**

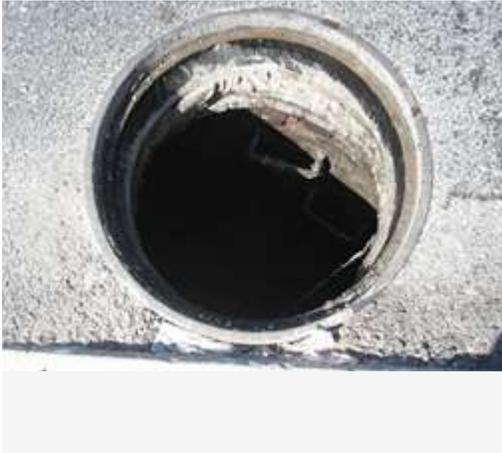
Frame View

Chimney / Frame Adjustment Exists Material: **Brick**

Condition: Sound Cracked **Root Intrusion** Loose Brick Deteriorated

Infiltration: None Joint Cracks Mortar Roots **Wall**
